## Cyrenaica Harbours Project 2025: Al Haniyah (Aptouchus)

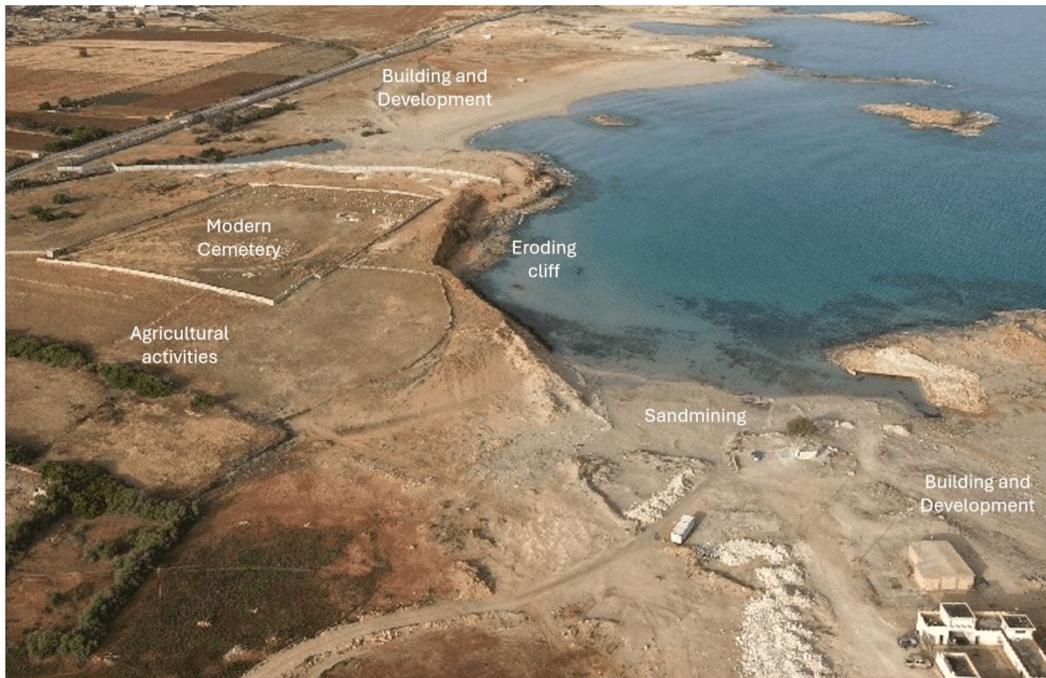
The project was designed as a detailed programme of archaeological survey and recording, prompted by growing threats to the site. These threats include (Fig. 1): coastal erosion exacerbated by winter storm surges; sand removal from the beach (sand mining), which destabilises the sediment in the bay, accelerating erosion; and modern development, primarily a tourist resort development in the western part of the bay on top of part of the archaeological site. There are also discussions about building a harbour in the immediate area that is large enough to facilitate international shipping and will require extensive clearance of the area. The primary aim of the 2025 fieldwork, therefore, was to document the surviving archaeology—both on land and underwater—before further damage or loss occurs.

Figure 1: Factors affecting the site of Aptouchous at al Haniyah.

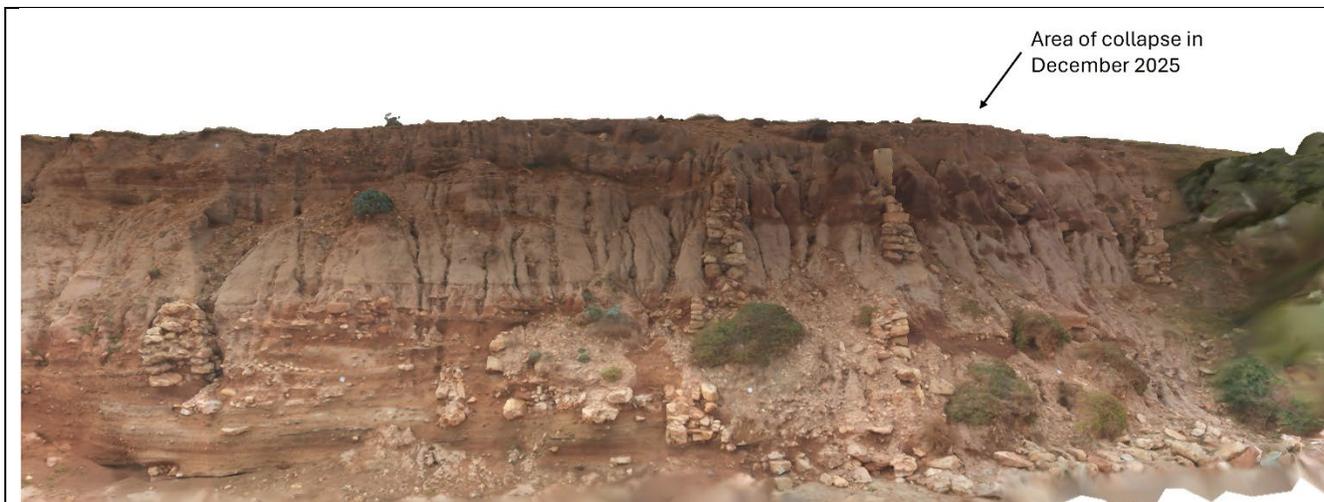
On land, the team carried out extensive recording of visible archaeological remains. This included detailed photography, drone survey, and the creation of 3D digital models of standing structures and the eroding sea cliff (Fig.2). These digital records capture the current condition of the site and can be repeated in the future to allow for future comparison as erosion continues. There were already notable changes in the state of the cliff face from a previous visit by team members in 2024 when compared to our fieldwork in 2025. Furthermore, a partial cliff collapse during winter storms in late 2025 occurred since our fieldwork.

Figure 2: Part of the model of the cliff face (Sector 8), showing numerous walls and stratigraphic layers.

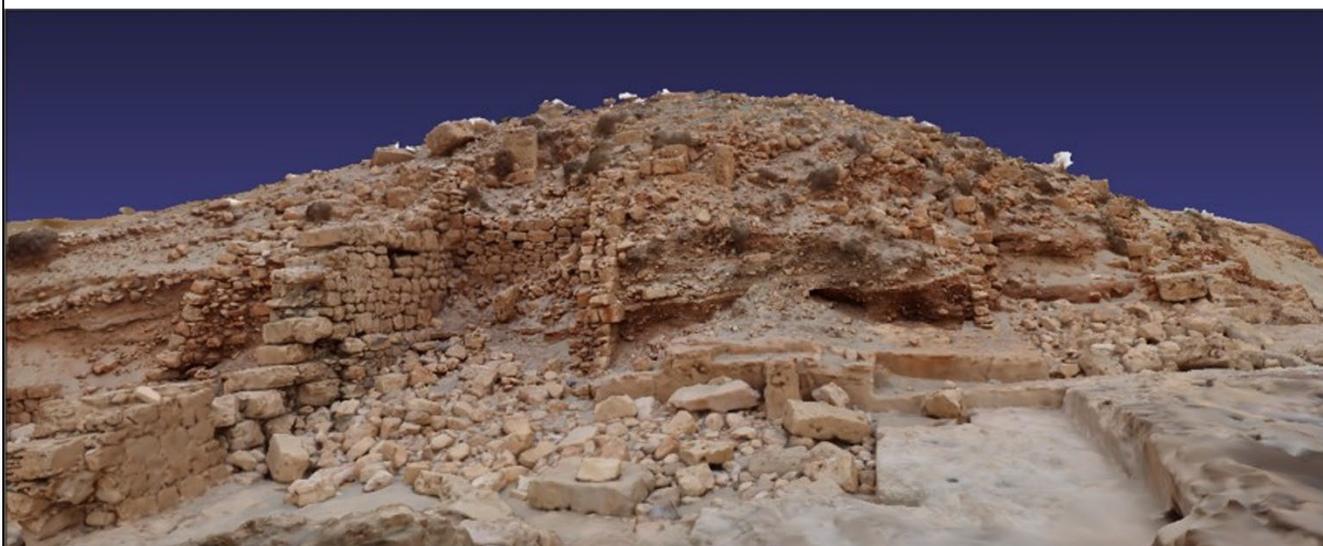
One significant result of this work was the recording of a large, multi-phase building within the area of the modern resort development, approximately 20 m from the eastern boundary wall of the development. Survey data shows that this structure occupied two levels and appears to have been on top of earlier rock-cut industrial features (that were possibly incorporated into the structure). In a later phase the building was fortified through the strengthening of the outer walls and the addition of sloped revetment walls, which are visible on the eastern and western sides (Fig. 3). Our work also examined earlier interpretations that suggested some features were kilns, but these appear to be rooms of this building that were damaged by a fire in antiquity. Elsewhere on the site, the team recorded quarrying, industrial installations (such as vats and tanks), and architectural elements including columns and fragments of mosaic flooring.

Figure 3: Image of the 3D model of the fortified building (facing south).

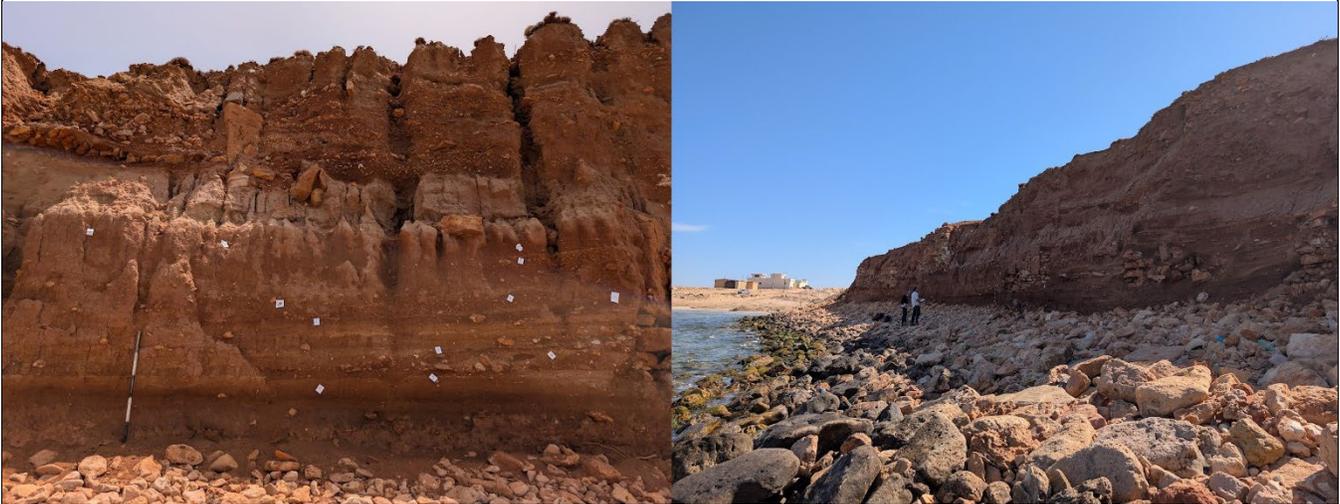
A key part of the research focused on the exposed cliff face, where erosion has revealed layers of archaeological deposits and structural remains. The team recorded individual layers and identified seventy-six walls within the 120-metre length of the cliff (Fig 4). Pottery was collected from some of these layers to help date different phases of occupation, with the lowest levels dated to at least the 5–6<sup>th</sup> centuries BCE, while the upper levels provide dates up to the 6<sup>th</sup> century CE. These layers and structural remains show how building techniques changed over time, and preserve evidence for domestic activity, destruction by fire, and late-phase burial practices. In several areas within the upper layers, human remains are visible where burials have been cut by erosion and collapse.

Figure 4: Left: Example of a small part of the stratigraphy of the cliff face. Right: Team members carrying out stratigraphic analysis of the cliff.

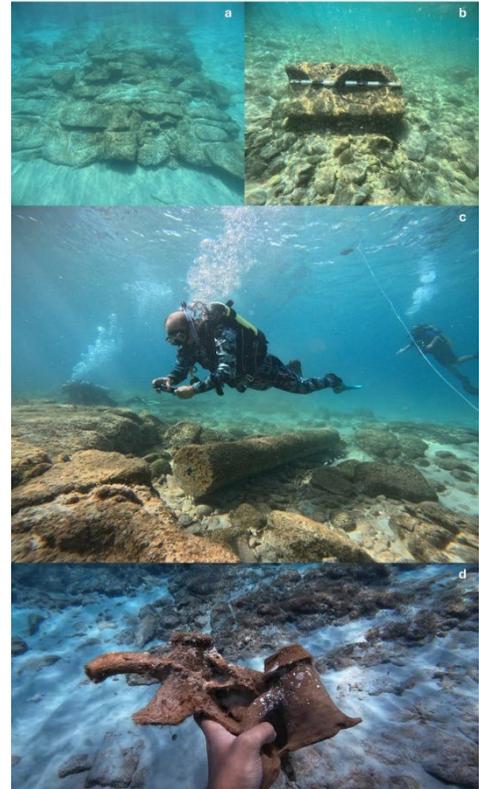
Underwater survey formed an essential component of the project. Divers focused on the main harbour bay and recorded stone anchors, pottery, fishing equipment, sections of columns, and large worked-stone blocks associated with harbour structures (Fig. 5). The discovery of features such as possible mooring areas and a breakwater confirms the presence of harbour infrastructure. They also investigated neighbouring bays to the west and identified further pottery and anchors that indicate boats also anchored beyond the main harbour area.

Figure 5: (a) stone structure; (b) architectural element; (c) column shaft; (d) fragments of two amphorae.
